Re: Feasibility Study to Move the Gulick House
Route 206 and Province Line Road
Lawrence Township, New Jersey

Moving the Gulick House Feasibility Study 7.13.21

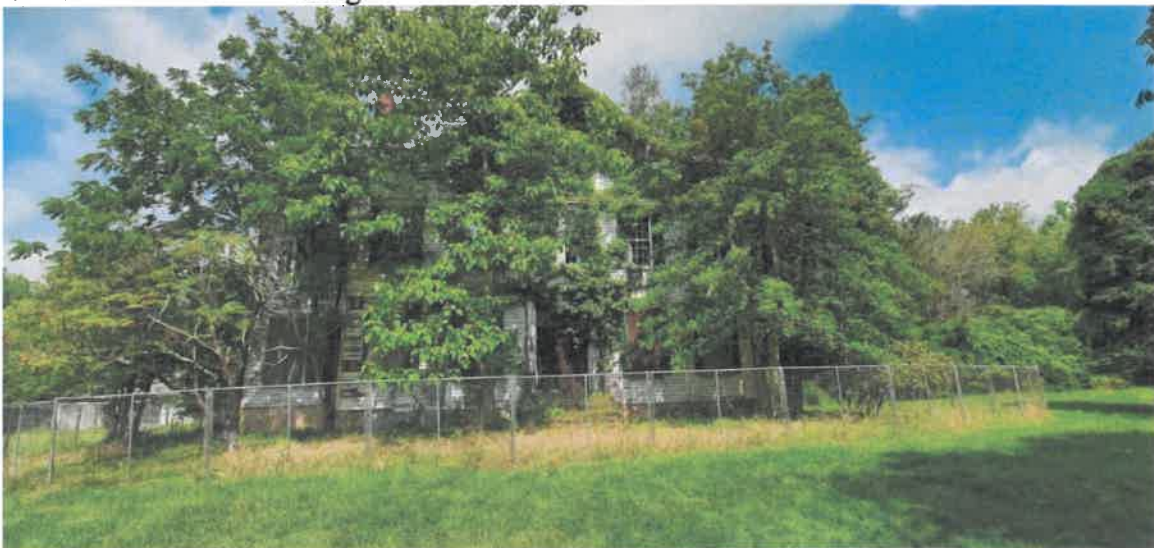
View of Front of the House Showing Overgrown Shrubbbery

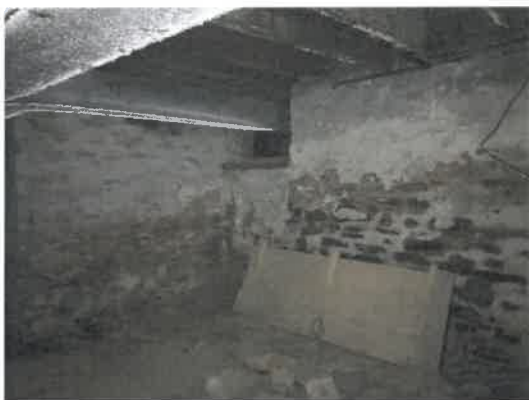
Ductwork to be Removed

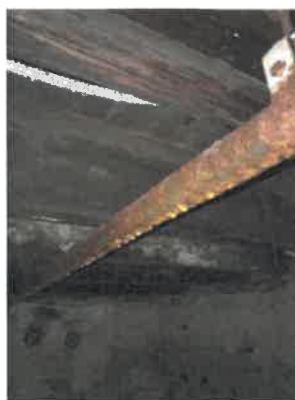
Steel Pipe to be Removed

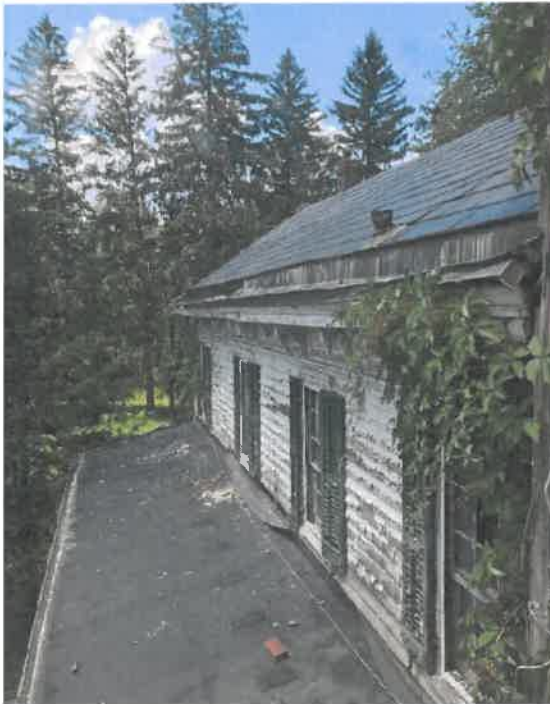
Servant's Wing Porch Roof and Gutter

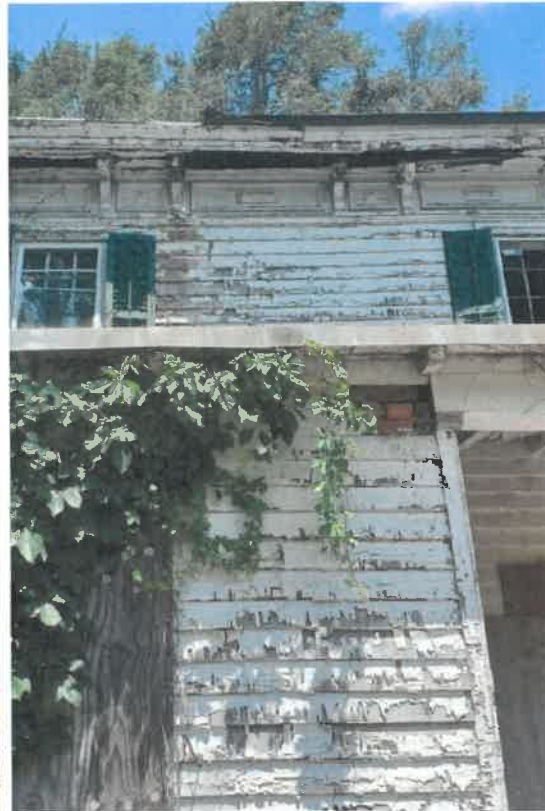
Servant's Wing West Side Soffit and Fascia

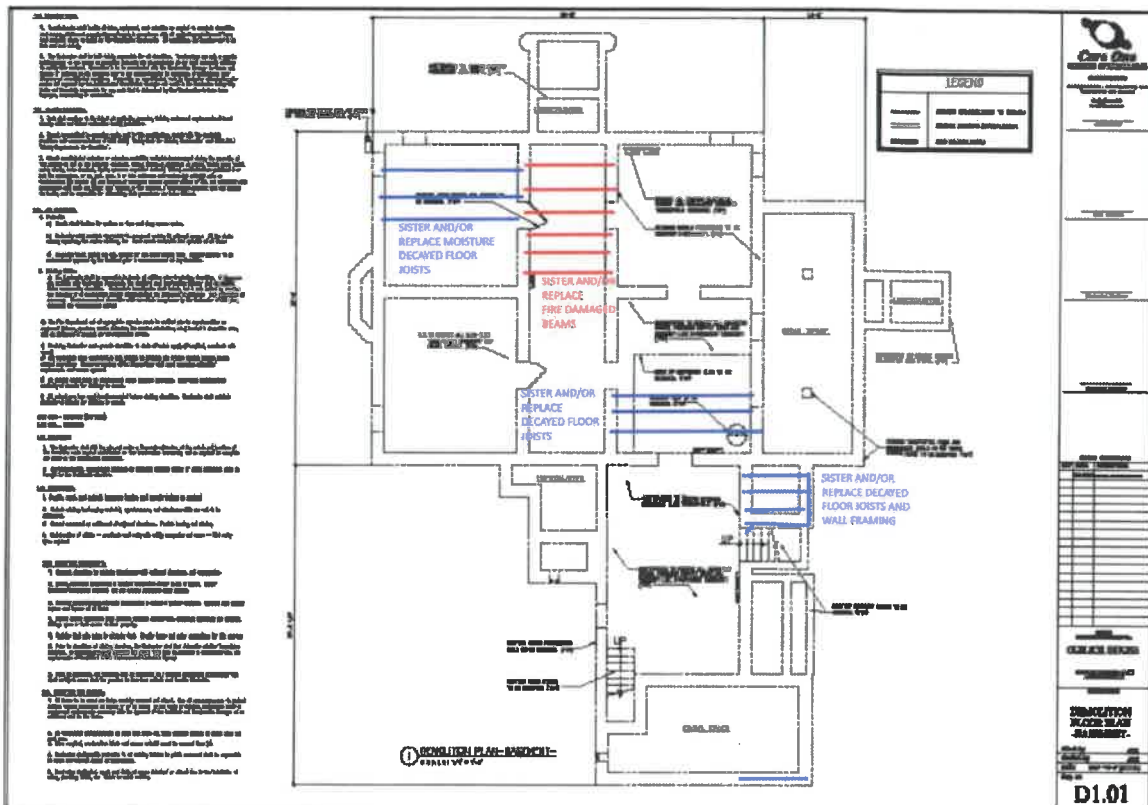
BASEMENT FLOOR JOIST REPAIRS

The floor joists in the basement are generally in serviceable condition. There are four main problem areas depicted in the photos above and can be remedied by placing another joist against the existing (best condition at the fire damaged floor joists under the front entry hallway) and or replaced in kind where joists are either insect or moisture damaged (dining, living and pantry areas). There are approximately a dozen or so joists that need to be addressed prior to the buildings removal and relocation. The sill plates/box beams at the buildings perimeter are most susceptible to insect damage as they are in direct contact with the stone foundation walls – that possible damage cannot be assessed until the house is lifted – the curative will be to replace in kind with pressure treated wood. The pantry located on the west side porch is as discussed previously above.

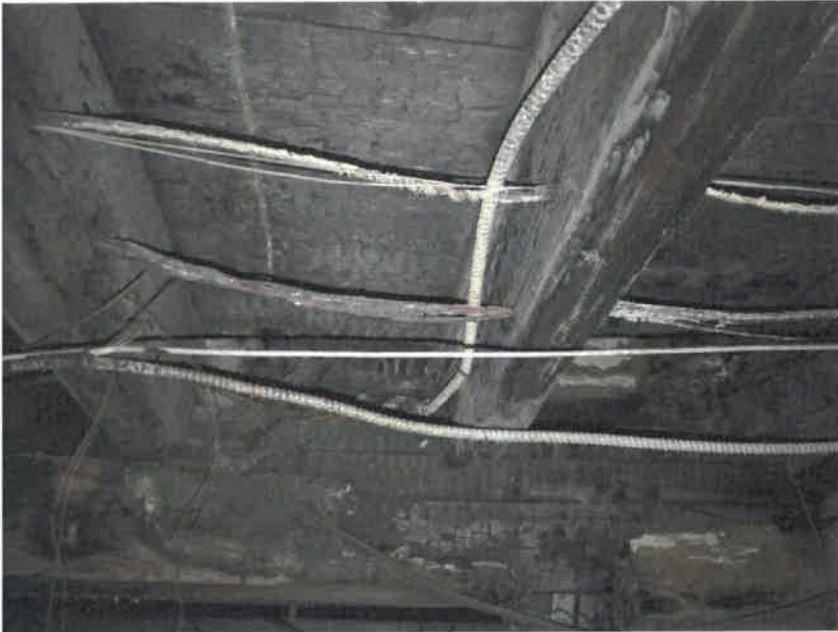
Fire Damaged Basement Floor Joists at Front Entry Hall

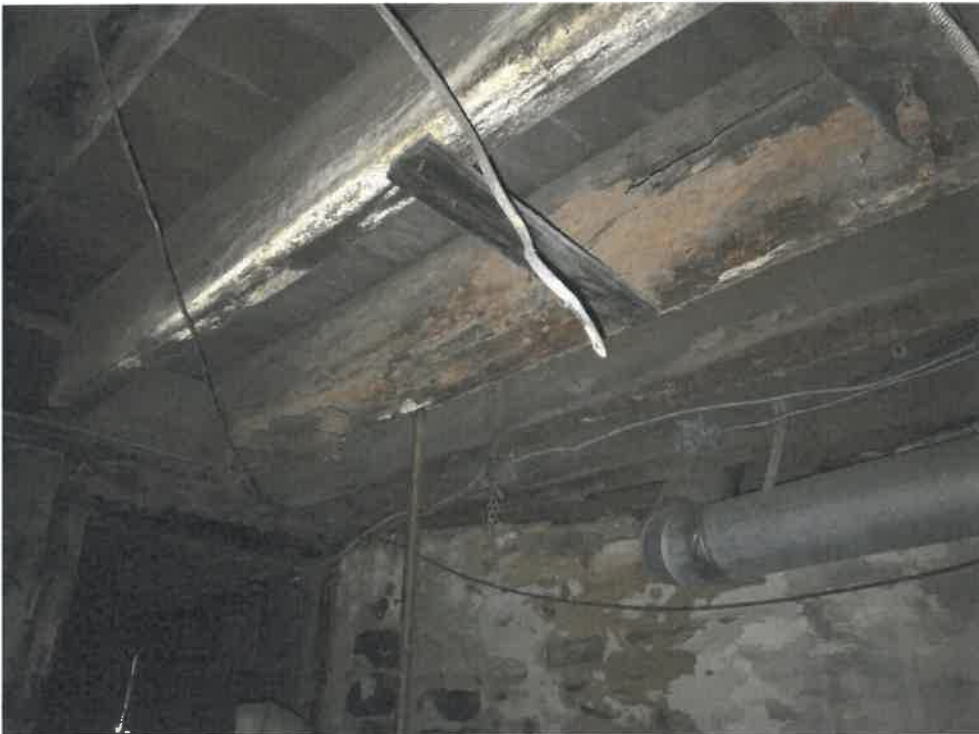
Moisture Decayed Floor Joists under Dining Room

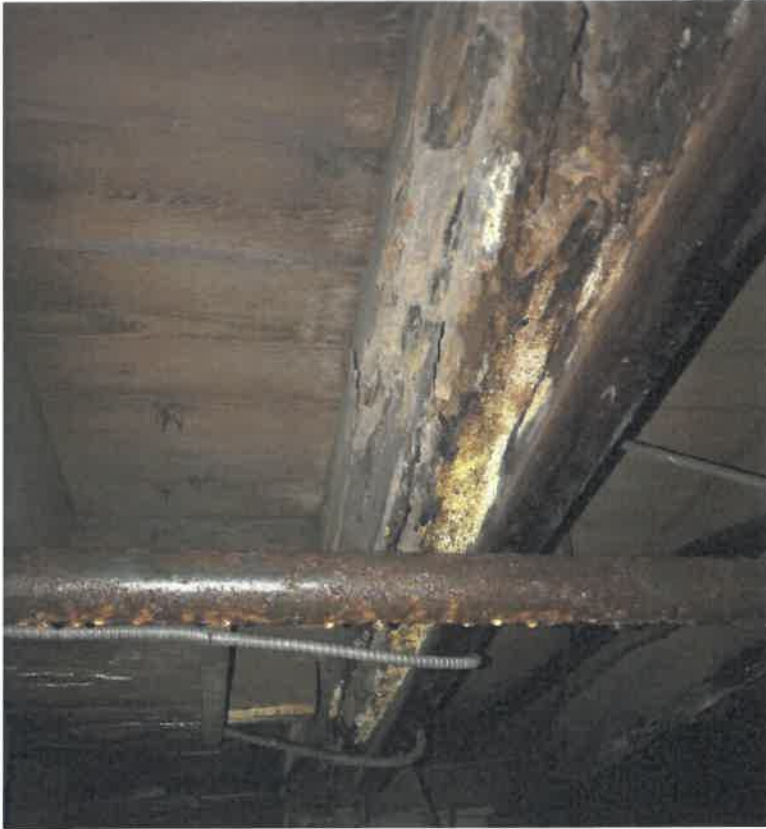
Moisture Decayed Floor Joists under Living Room

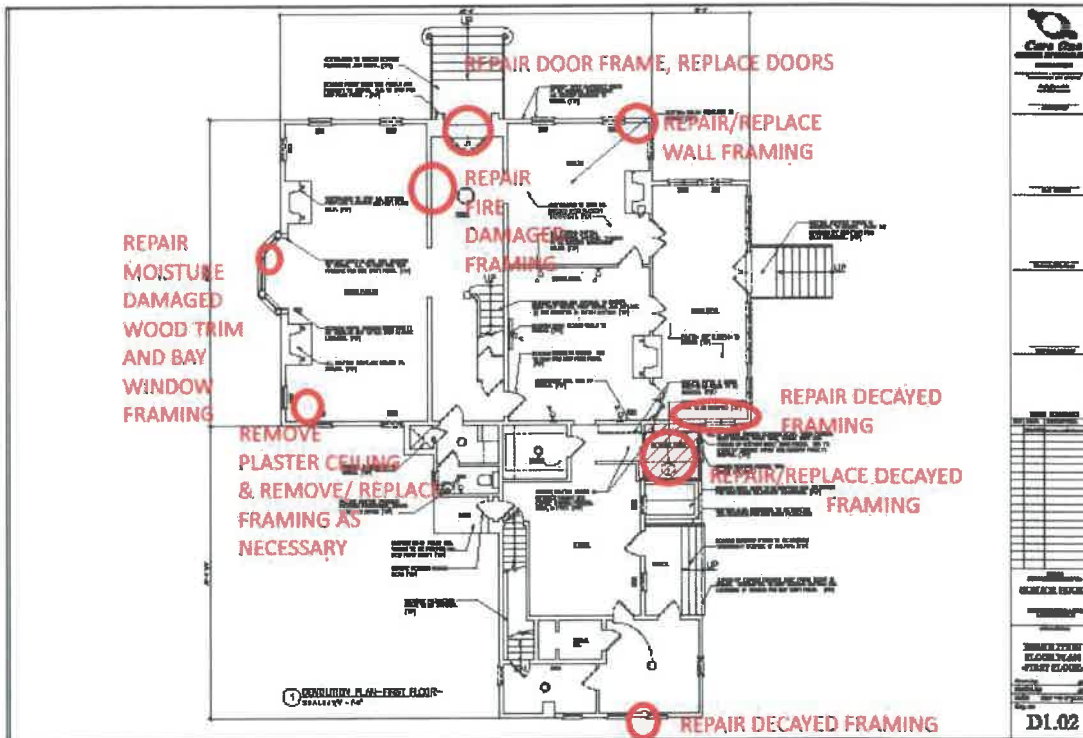
FIRST FLOOR REPAIRS

The first-floor repairs as depicted in the floor plan above are varied and range from relatively minor repairs to the bay window to more exhaustive repairs to the pantry flooring, walls and roofing. The living and dining room ceilings have damaged plaster due to roof leaks above. There is fire damage to the walls and floors of the entry hall. There is hole in the front wall due to siding damage at the front south-west corner of the house. The areas that most affect the structural integrity of the house are the front corner, the fire damage and the pantry areas. Additional damage may be discovered once the elevator shaft is removed and until areas are completely opened up to assess damage the full extent of the work is not known. Despite the aforementioned distressed areas the house is amazingly level and plumb and the plaster work is in reasonable condition save for the peeling paint. The sunroom is likewise in serviceable condition except the rear portion facing the servant's wing has water damage caused by roof leaks above – this area will need to be either reconstructed or braced prior to moving. The first floor is in structurally sound condition overall. Many of the repairs are cosmetic and do not affect the structure of the house. The three story staircase is in amazingly original condition and will be the major focal point of the house once restored.

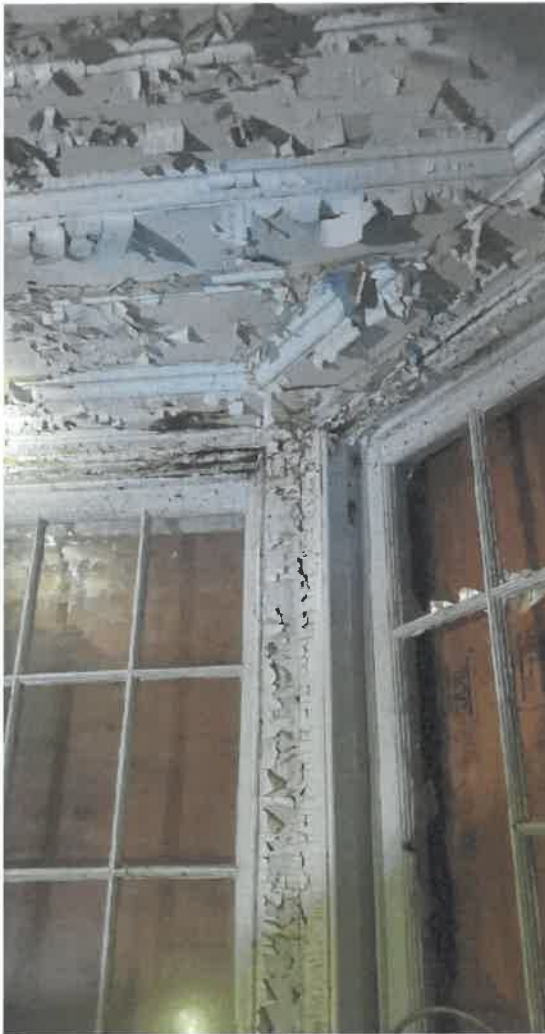
Damage at Bay Window

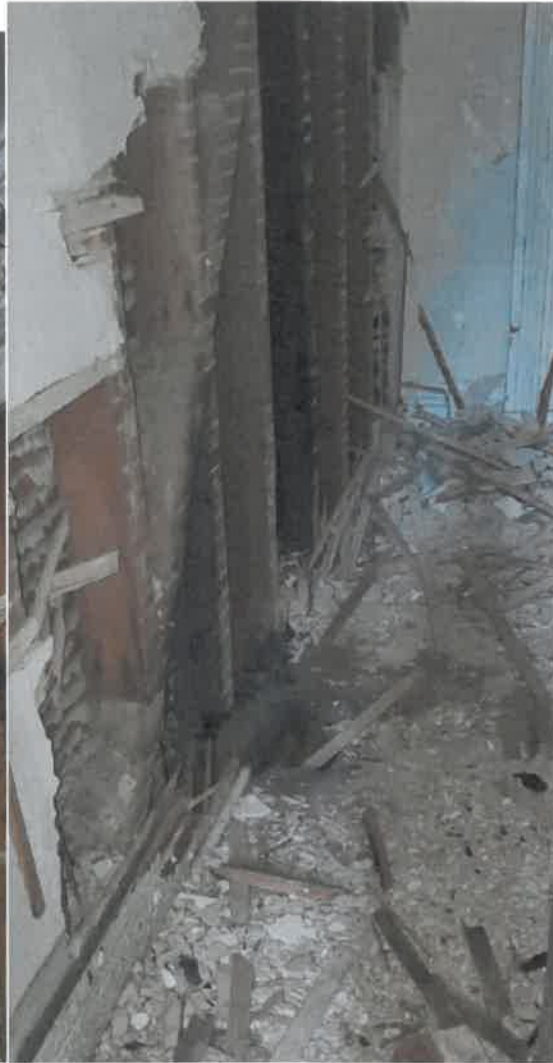
Front Entry Fire Damage

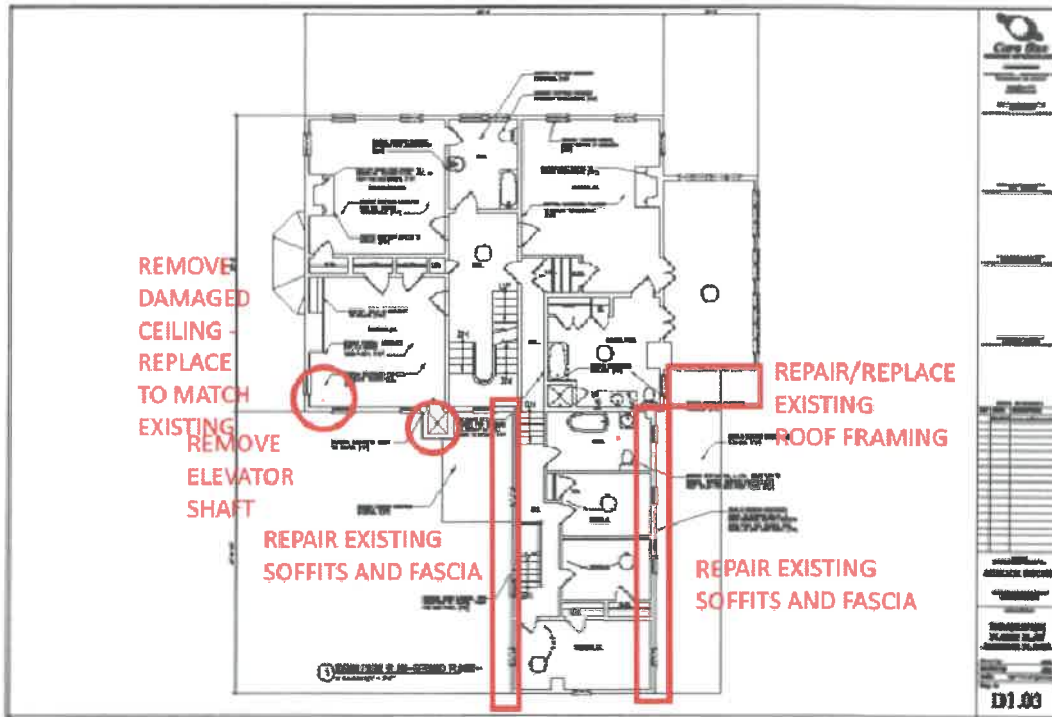
SECOND FLOOR REPAIRS

The second floor has several problems area that are mostly due to defects in the roof. The right rear bedroom of the main house has a large hole in he ceiling that opens up the attic eave above. Ceiling joists have some deterioration and the walls may have further decay and will have to be opened to determine the extent of the damage. This is the most significant damage that is apparent on the interior of the house – the other damage is evident on the exterior and consists of soffits, fascias and built in gutters. The majority of the damage is on the servant's wing but the rear of the first-floor sunroom/pantry roof is in very poor condition and will most probably need to be wholly reconstructed. There are several areas of holes within bathroom walls but these are largely cosmetic issues and do not affect the structural integrity of the house. Again, the floors are largely level, the walls plumb, the plaster work largely intact and this level is structurally sound. The house mover may again recommend internal temporary bracing especially at the sun room.

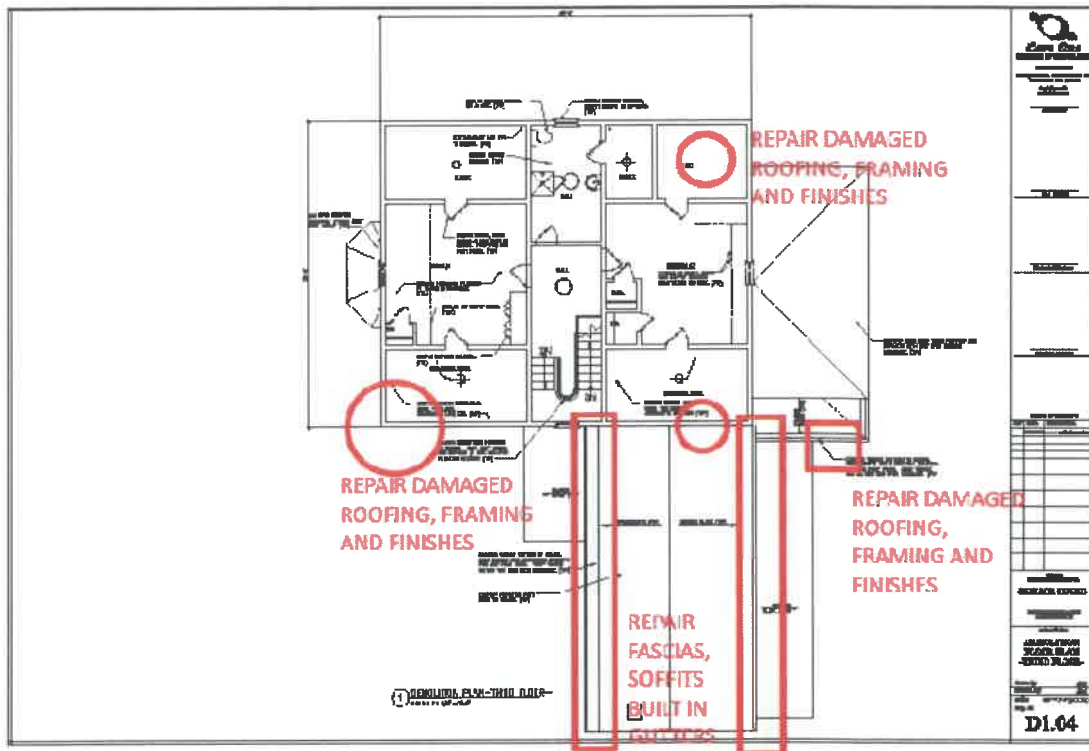
THIRD FLOOR REPAIRS

Third floor repairs are again due to penetrations in the roof and are manifest in the right rear eave of the east bedroom and front and rear eaves of the west bedroom. The right rear has caused the most damage. Again, built in gutters are shown on the servant's wing to emphasize that degree of decay. The third level is similarly plumb and level and other than the roof leaks the repairs are largely cosmetic in nature.

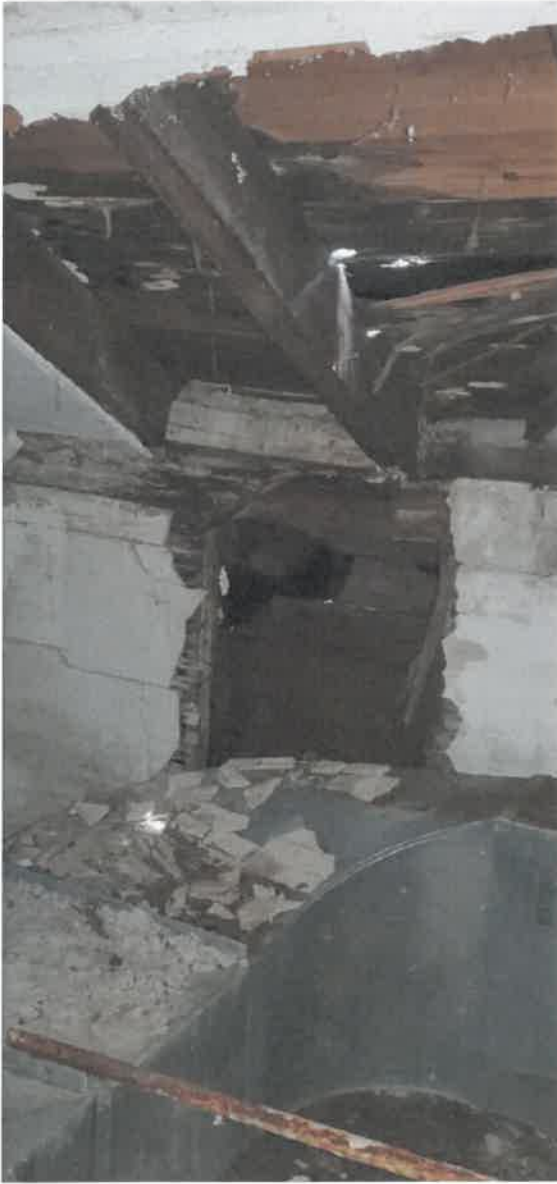
Damage Within Eaves

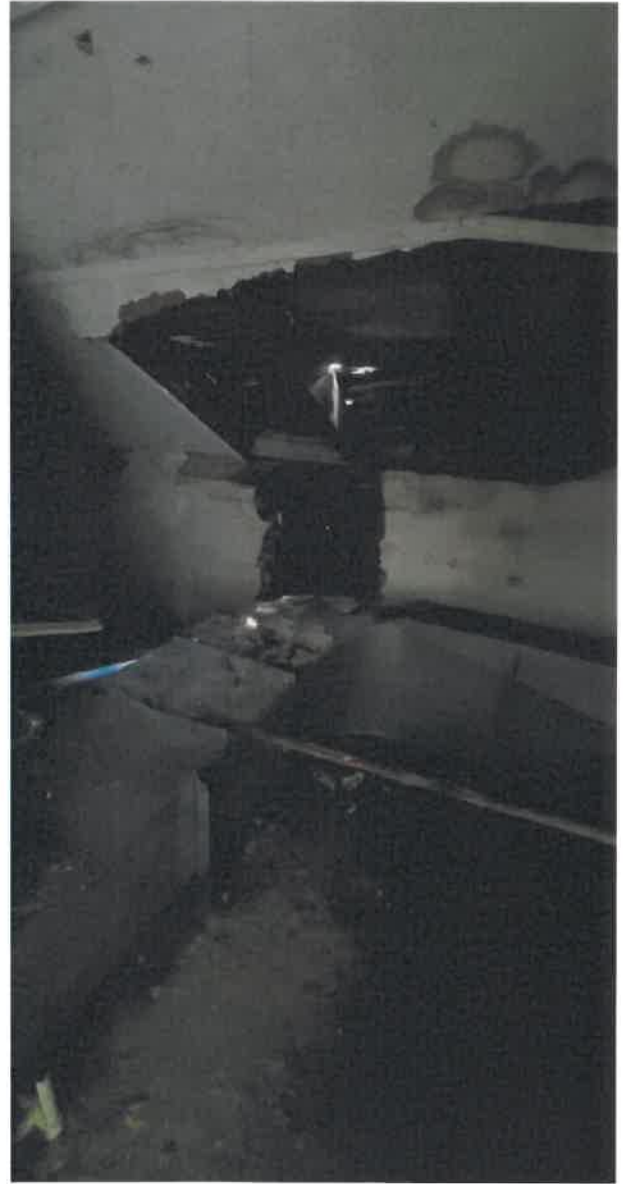
Damage Within Eaves
