**Re: Stormwater Subsurface Investigation Summary Letter
Proposed CareOne Assisted Living Facility
Block 6601, Lot 2
3641 Lawrenceville Road
Lawrence Township, Mercer County, New Jersey 08540
RPM Project #: 61-150**

RPM Engineering LLC (RPM) performed a subsurface investigation at the above referenced site in order to investigate the soil and groundwater conditions in the location of the proposed stormwater management facilities. This Letter serves to transmit the results of our investigation.

DRAWING TITLE
**TEST PIT
 LOCATION PLAN**

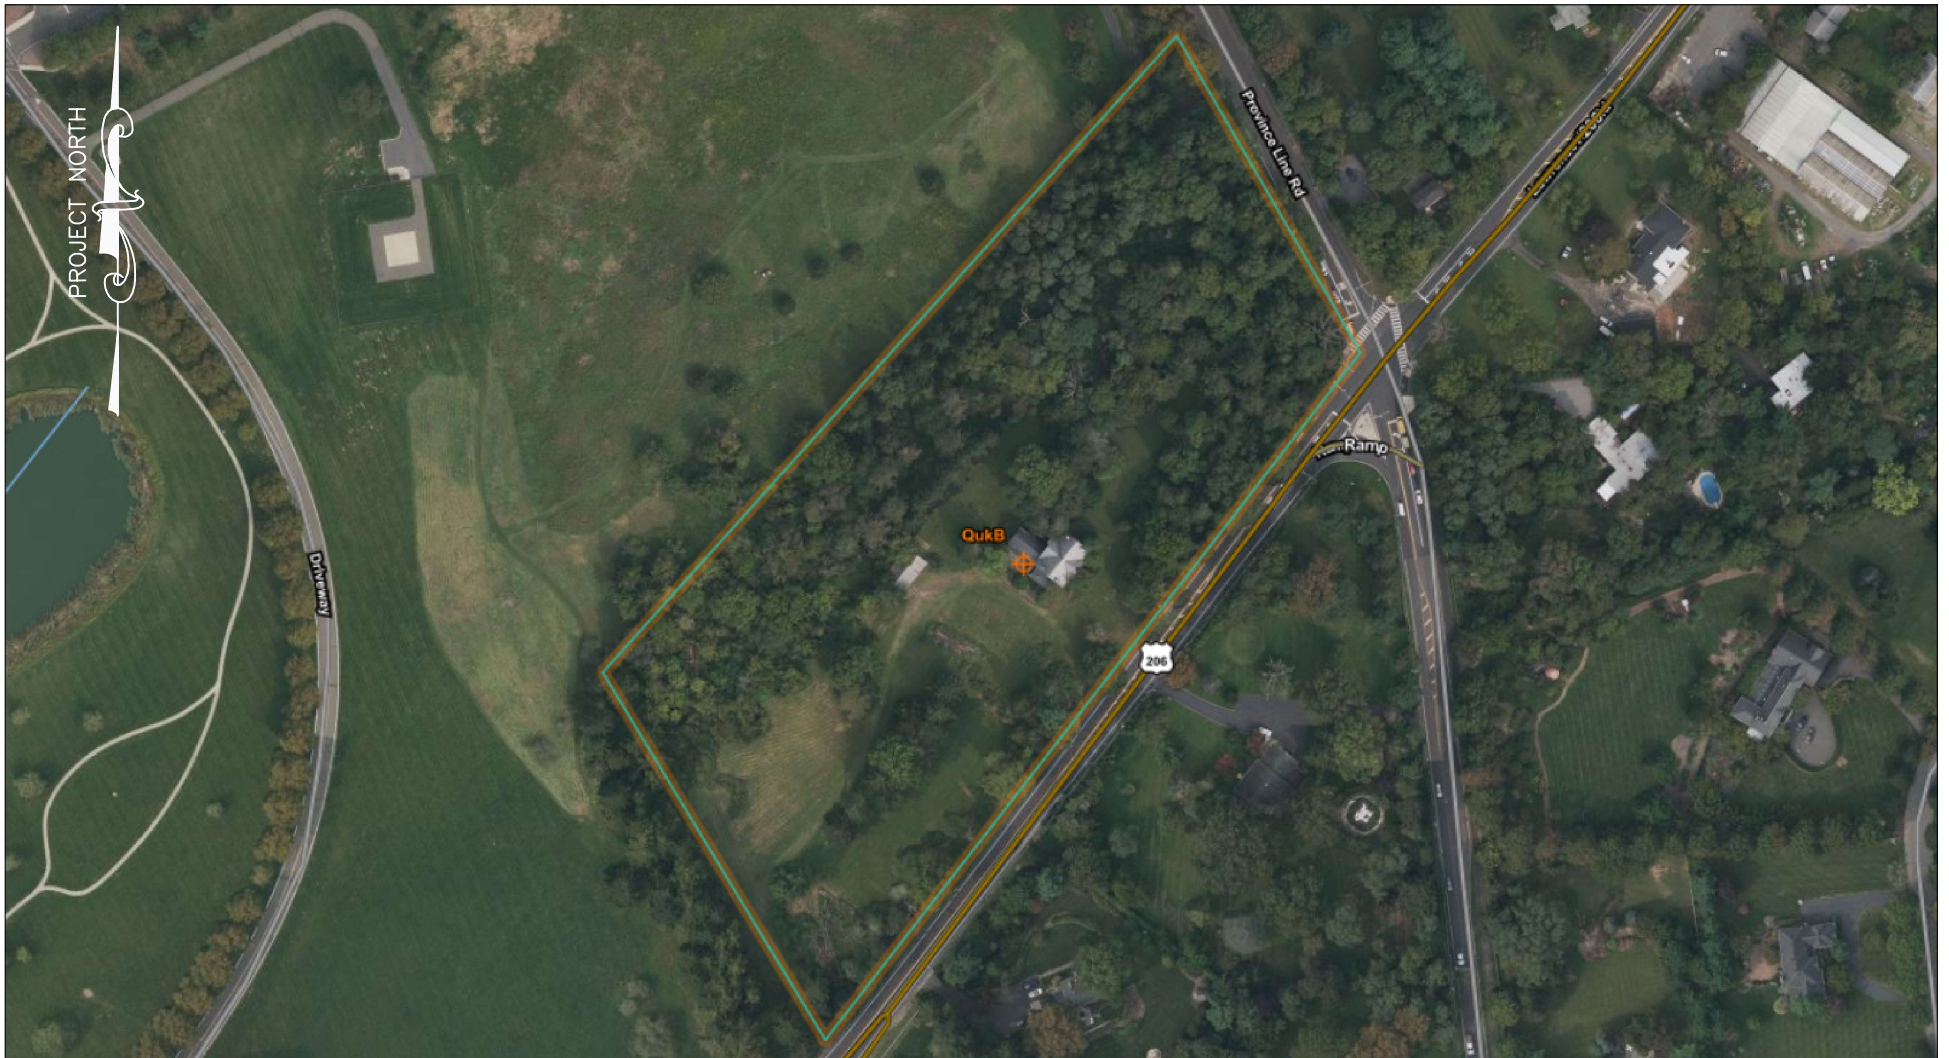
**ATTACHMENT
 'B'**

We reviewed the soils mapping of the project site as provided by the United States Department of Agriculture (USDA) Natural Resources Conservation Service (NRCS) for Mercer County, New Jersey as provided by the Web Soil Survey. The soil type mapped on the proposed project site is identified as the Quakertown silt loam (QukB), 2 to 6 percent slopes.

A plan showing the soil mapping areas in the vicinity of the site has been provided as Attachment B, *Soil Map*.

UNIT SYMBOL:	UNIT NAME:
QukB	QUAKERTOWN SILT LOAM, 2% TO 6% SLOPES

SOIL MAP
