Re: Feasibility Study to Move the Gulick House
Route 206 and Province Line Road
Lawrence Township, New Jersey

Moving the Gulick House Feasibility Study 7.13.21

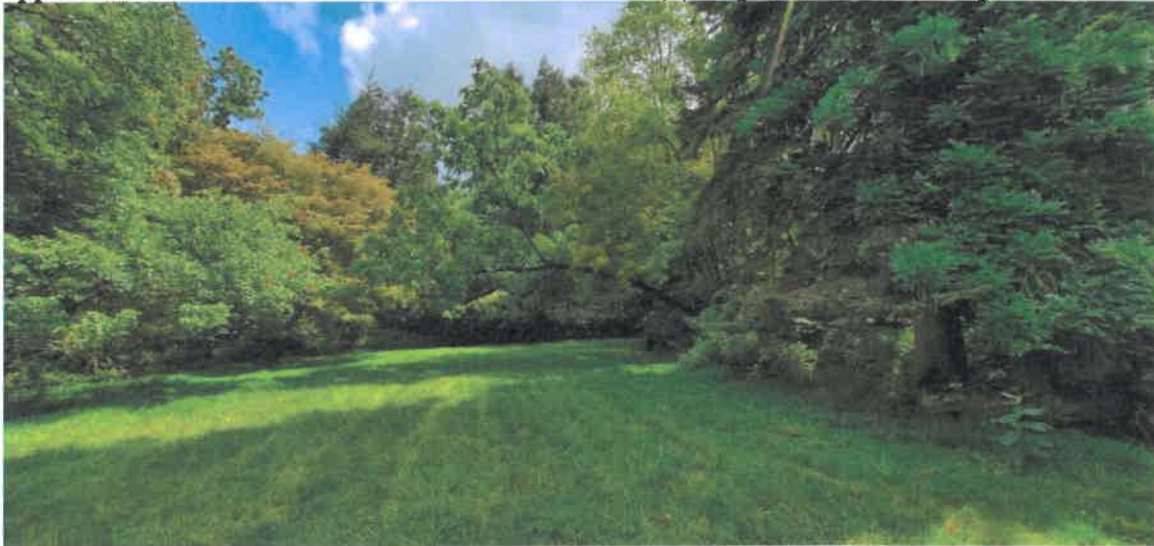
View of Side Yard Looking Toward Relocation Site

The site is relatively level and is heavily treed with a clearing to the east amongst the trees and clear lands to the south (front) and west. What was originally planted as shrubbery have become mature if not overgrown trees extremely close to the house and must be removed to gain access to all sides of the house. The move will require adequate tree removal to create a path to transport the house as well as room around the new location to facilitate the construction of the new foundation and relocation work. Site utilities will also require excavation for underground sewer, water, electrical and telecommunications. A new driveway off of Province Line and parking will also need to be constructed. There appear to be no insurmountable site conditions that would prohibit the moving of the house.

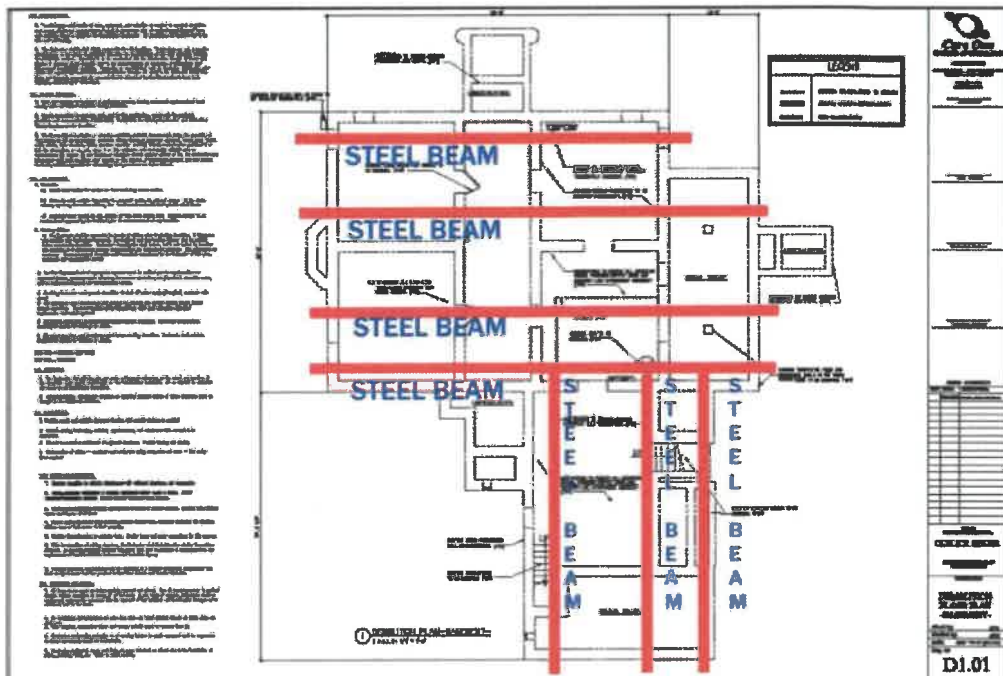
Plan Showing Approximate Location of Steel Beams – often a square lattice is made with cross beams to minimize the number of steel beams attached to dollies/wheels

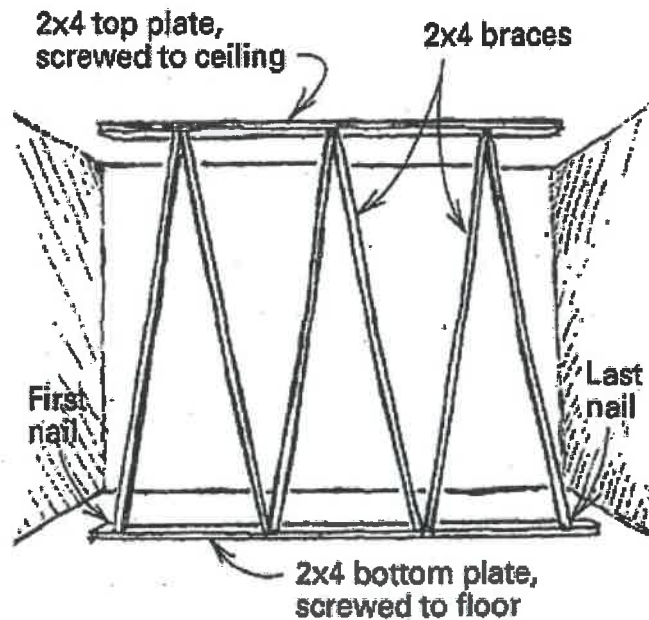
Bracing Detail for Interior Walls

The house mover will make suggestions as to the bracing of the interior of the house – the rooms are large and the ceilings tall and there are few partitions walls on the first floor to keep the main house from racking; however the rear wing helps to anchor the main block and minimal bracing should be the order of the day if any. The mover will also walk through the house and help the owner to make a checklist of things to be done prior to the move. The nogging between the walls has to be confirmed as that adds significant weight and has to be accounted for with the hydraulic jacking system. Likewise the framing appears to be balloon framed and additional work may be required to tie the first flooring decking to the wood stud wall system and sill plate if it is not platform framed.

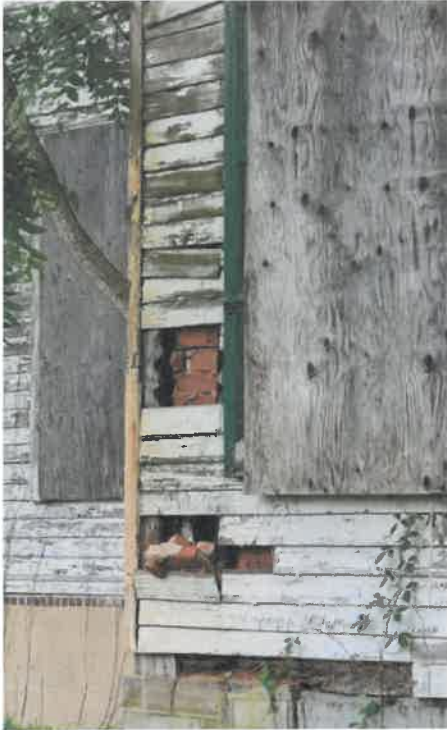
Front South-West Corner of House

The time that the house has been vacant has not been kind. Vandals have entered the house, stolen its historic mantels, broken out its windows, stolen copper from its built in gutters and downspouts. All of this has led to further decay. Extreme plant growth near the building's perimeter and general lack of maintenance has also taken its toll on the building's exterior. Peeling paint, missing roof shingles, crumbling brick stoops, loose wrought iron handrails, rotting fascias and soffits all point to problems with the house on the exterior.

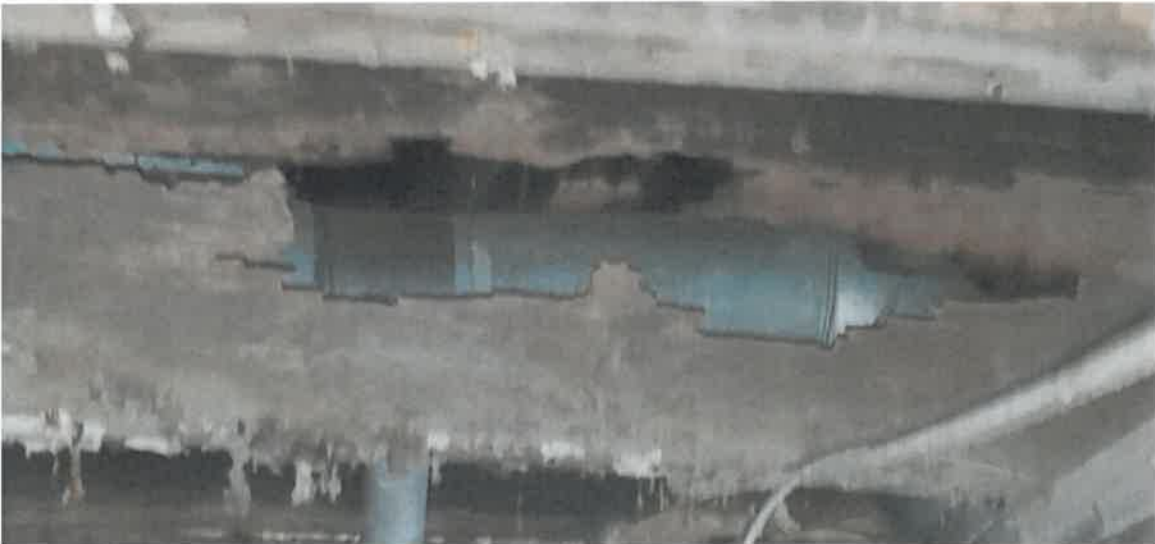
The floor joists in the basement are generally in serviceable condition. There are four main problem areas depicted in the photos above and can be remedied by placing another joist against the existing (best condition at the fire damaged floor joists under the front entry hallway) and or replaced in kind where joists are either insect or moisture damaged (dining, living and pantry areas). There are approximately a dozen or so joists that need to be addressed prior to the buildings removal and relocation. The sill plates/box beams at the buildings perimeter are most susceptible to insect damage as they are in direct contact with the stone foundation walls – that possible damage cannot be assessed until the house is lifted – the curative will be to replace in kind with pressure treated wood. The pantry located on the west side porch is as discussed previously above.

Floor Joist under Dining Room

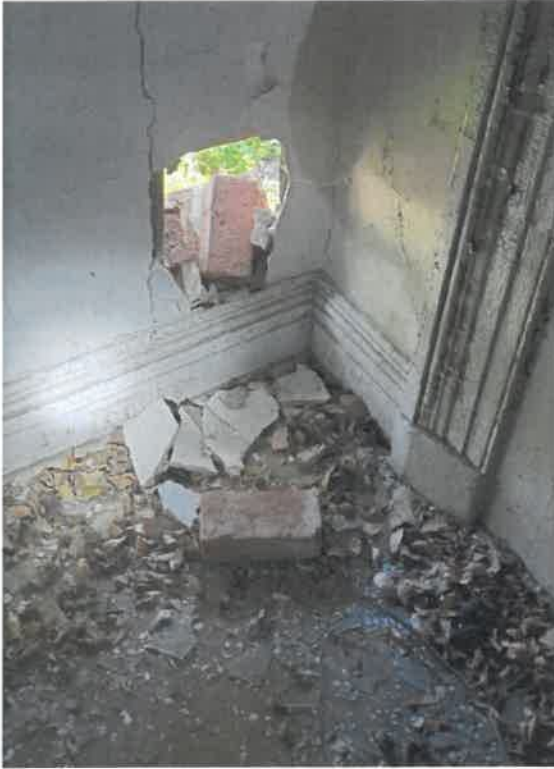
Corner of Dining Room

The first-floor repairs as depicted in the floor plan above are varied and range from relatively minor repairs to the bay window to more exhaustive repairs to the pantry flooring, walls and roofing. The living and dining room ceilings have damaged plaster due to roof leaks above. There is fire damage to the walls and floors of the entry hall. There is hole in the front wall due to siding damage at the front south-west corner of the house. The areas that most affect the structural integrity of the house are the front corner, the fire damage and the pantry areas. Additional damage may be discovered once the elevator shaft is removed and until areas are completely opened up to assess damage the full extent of the work is not known. Despite the aforementioned distressed areas the house is amazingly level and plumb and the plaster work is in reasonable condition save for the peeling paint. The sunroom is likewise in serviceable condition except the rear portion facing the servant's wing has water damage caused by roof leaks above – this area will need to be either reconstructed or braced prior to moving. The first floor is in structurally sound condition overall. Many of the repairs are cosmetic and do not affect the structure of the house. The three story staircase is in amazingly original condition and will be the major focal point of the house once restored.

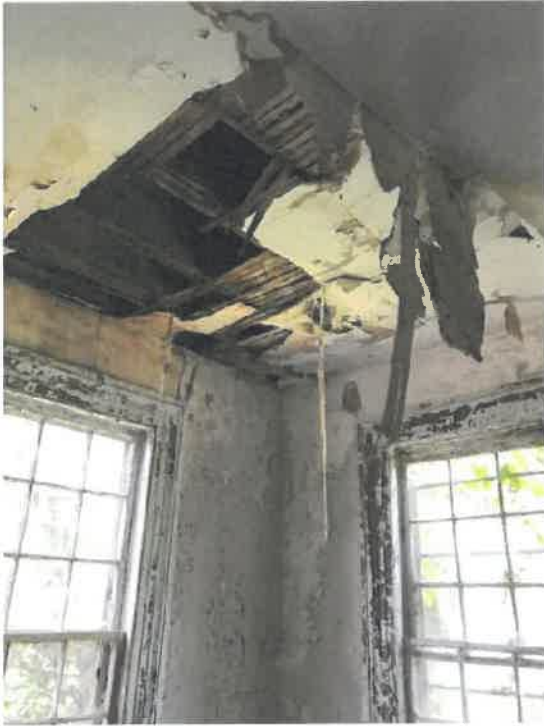
Rear Bedroom – Main House

The second floor has several problems area that are mostly due to defects in the roof. The right rear bedroom of the main house has a large hole in he ceiling that opens up the attic eave above. Ceiling joists have some deterioration and the walls may have further decay and will have to be opened to determine the extent of the damage. This is the most significant damage that is apparent on the interior of the house – the other damage is evident on the exterior and consists of soffits, fascias and built in gutters. The majority of the damage is on the servant's wing but the rear of the first-floor sunroom/pantry roof is in very poor condition and will most probably need to be wholly reconstructed. There are several areas of holes within bathroom walls but these are largely cosmetic issues and do not affect the structural integrity of the house. Again, the floors are largely level, the walls plumb, the plaster work largely intact and this level is structurally sound. The house mover may again recommend internal temporary bracing especially at the sun room.
